AN ARCHEOLOGICAL SURVEY OF THE MISSISSIPPI RIVER 9' CHANNEL

1375 DREDGE DISPOSAL SITES, POOLS 5A, 6, 7, AND 8

RICHARD B. LAHE

a report by: Richard B. Lane
Department of Sociology &
Anthropology
Saint Cloud State University
Saint Cloud, Minnesota

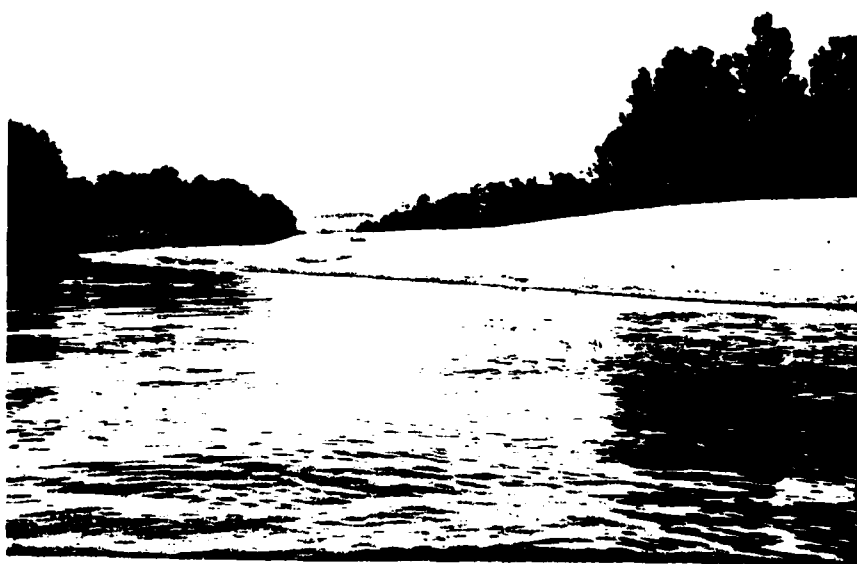
PLATE I

General view of the site number 5 area, Above Brownsville, Pool 8.
This is illustrative of the more recent, high elevation, dredge
spoil dumping area.

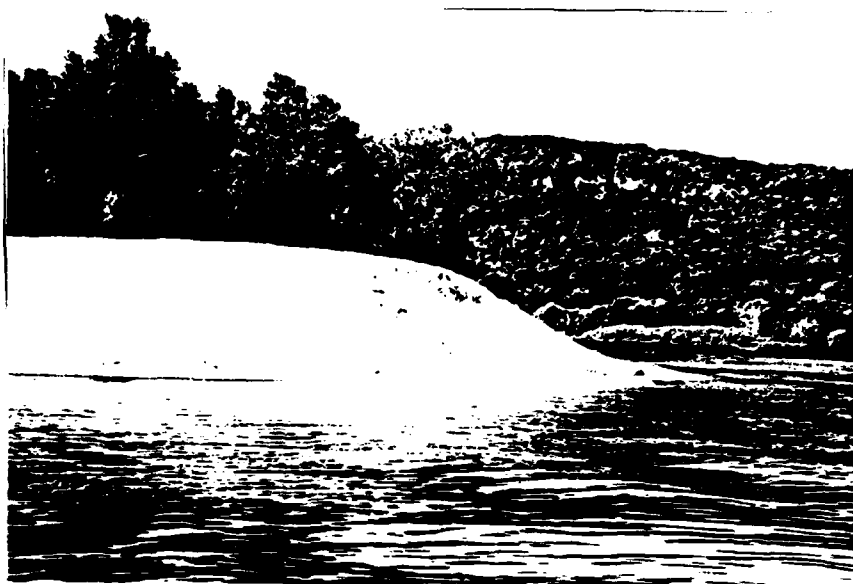
PLATE II

General view of the site numbers 7 and 8 area, Above Brownsville, Pool 8. This also is illustrative of the higher elevations which result from dredge spoil dumping.

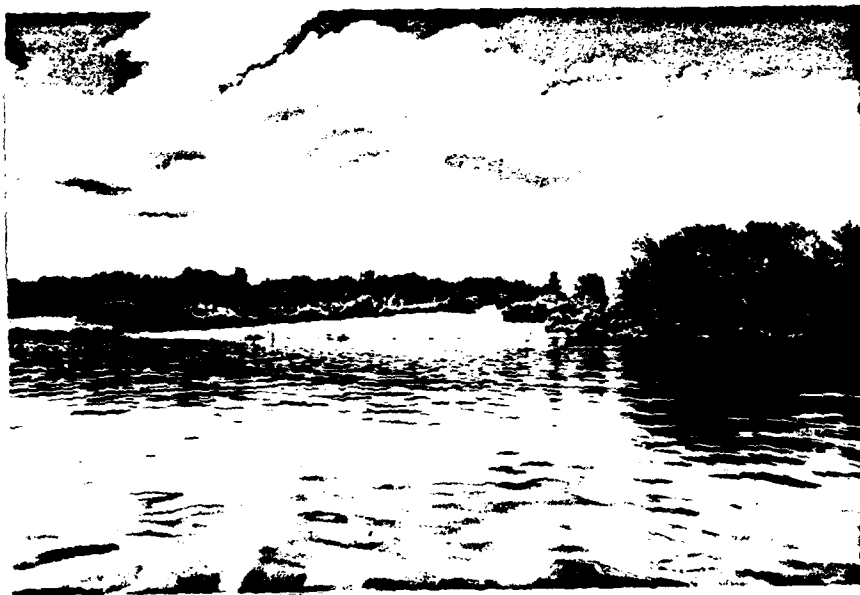
PLATE III

Richmond Island, site number 10: This is a primary dredge disposal site (Plate III shows "as found" conditions), but has already been used as a dredge spoil dump. Testing of the area (see Plate XI) proved negative; the area is considered sterile.

General view of the site number 10 area, Richmond Island, Pool 7.
This illustrates the outward spread of the dredge spoil dumps.

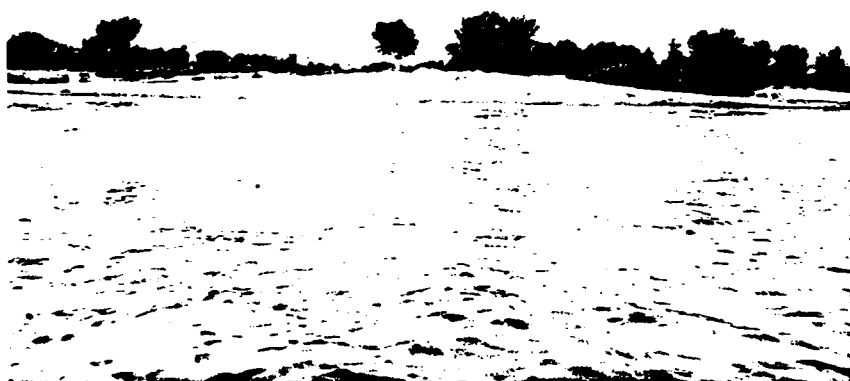
PLATE IV

General view of the site number 1 area, Dakota, Minn., Pool 7.

This illustrates the down river extension of the dredge spoil dumping.

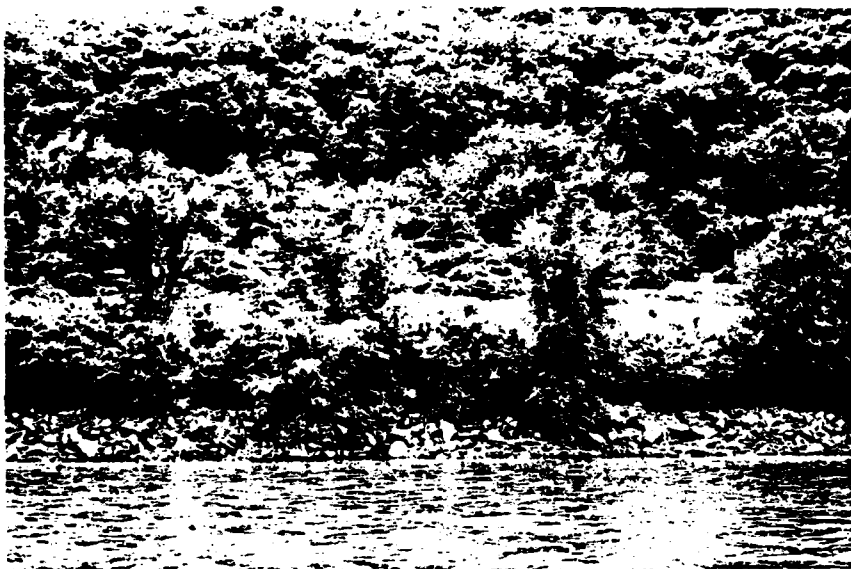
PLATE V

General view of the site number 1 area, Upper Homer, Minn., Pool 6.
This illustrates the use of large rocks and cement fragments as bank
protection.

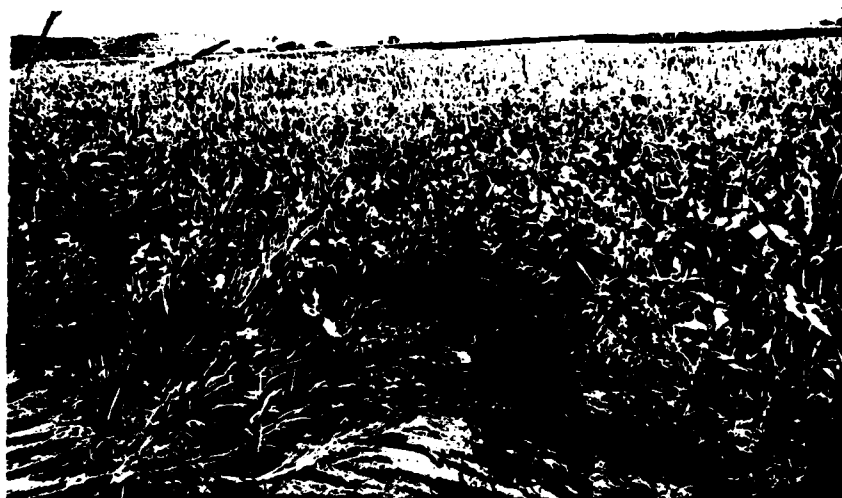
PLATE VI

General view of site number 1 and environs, Below head of Raft Channel, Pool 8. This is a fairly representative example of the site areas under water.

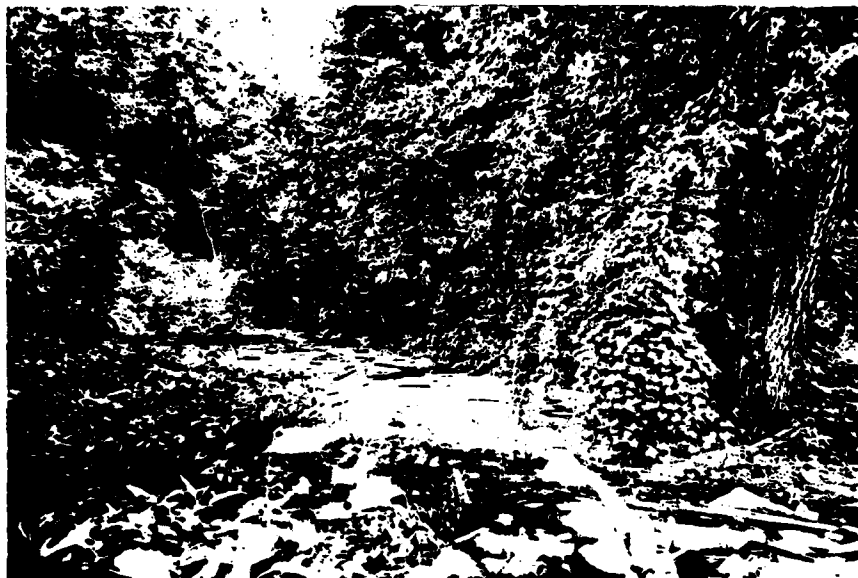
PLATE VII

General view of the site number 5 area, Above La Crosse R.R. Bridge,
Pool 8. This is more or less typical of the low-lying, recently flooded
site areas.

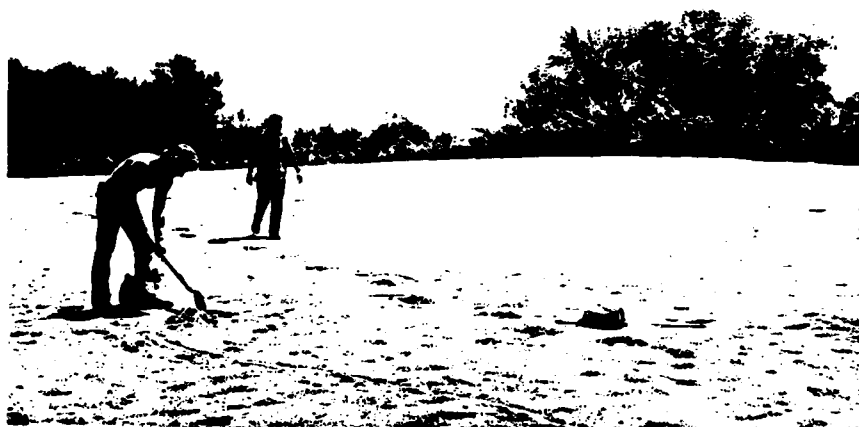
PLATE VIII

Upon landing, the area to be surveyed was subjected firstly to a walkover surface analysis to check for the presence of cultural material (see Plate VIII). Whether or not surface indications were present in the area, at least one large test pit, 1 meter (39.36 inch) square, was excavated. The placement of the large test pit would normally be based on the presence of surface indications or cultural material, but if none were found, the large test pit would be placed in the central portion of the area under examination (see Plate IX for an example of large test pitting). The large test pits were excavated to sterile zones or water level (see Plate X) and averaged approximately 2 meters (78.72 inches) in depth. Smaller test pits, 50 centimeters (19.68 inches) square, were excavated at intervals of approximately 20 meters (64 feet) along north/south (magnetic) lines and east/west lines to the edges of the survey area (see Plates XI and XII). These too were excavated to a sterile level or to the water level. All soil excavated in these test pits, large or small, was screened through 0.64 centimeter (one-quarter inch) wire mesh to insure recovery of small items which might have been missed during the process of excavation. All

An example of the walk-over phase of surface analysis on site number 6, Island 58, Pool 5A. The dredge spoil shown is relatively recent, less than 2 years old.

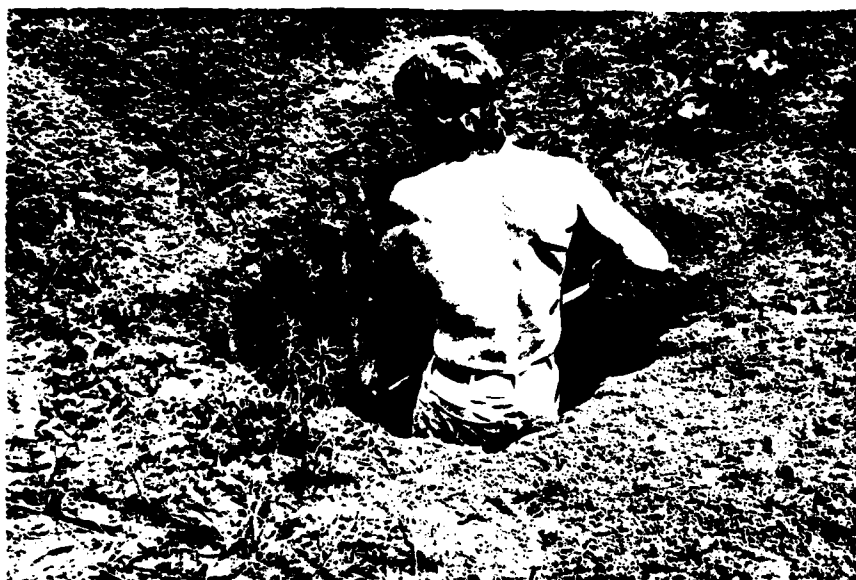
PLATE IX

Example of central, 1 meter square, test pit, in process of excavation, located in site number 4, Richmond Island, Pool 5A.

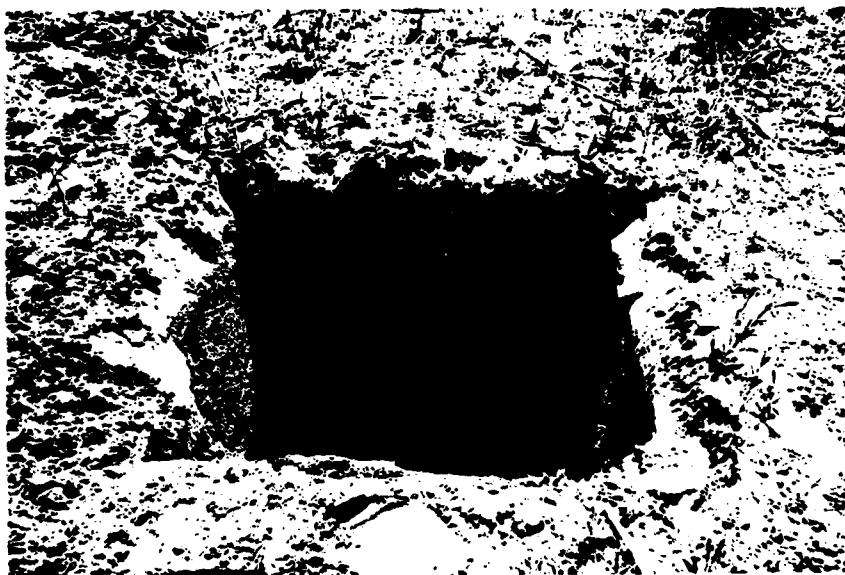
PLATE X

General view of a completed test pit, to water level (note base of pit), in site number 5, Below Head of Raft Channel, Pool 8.
